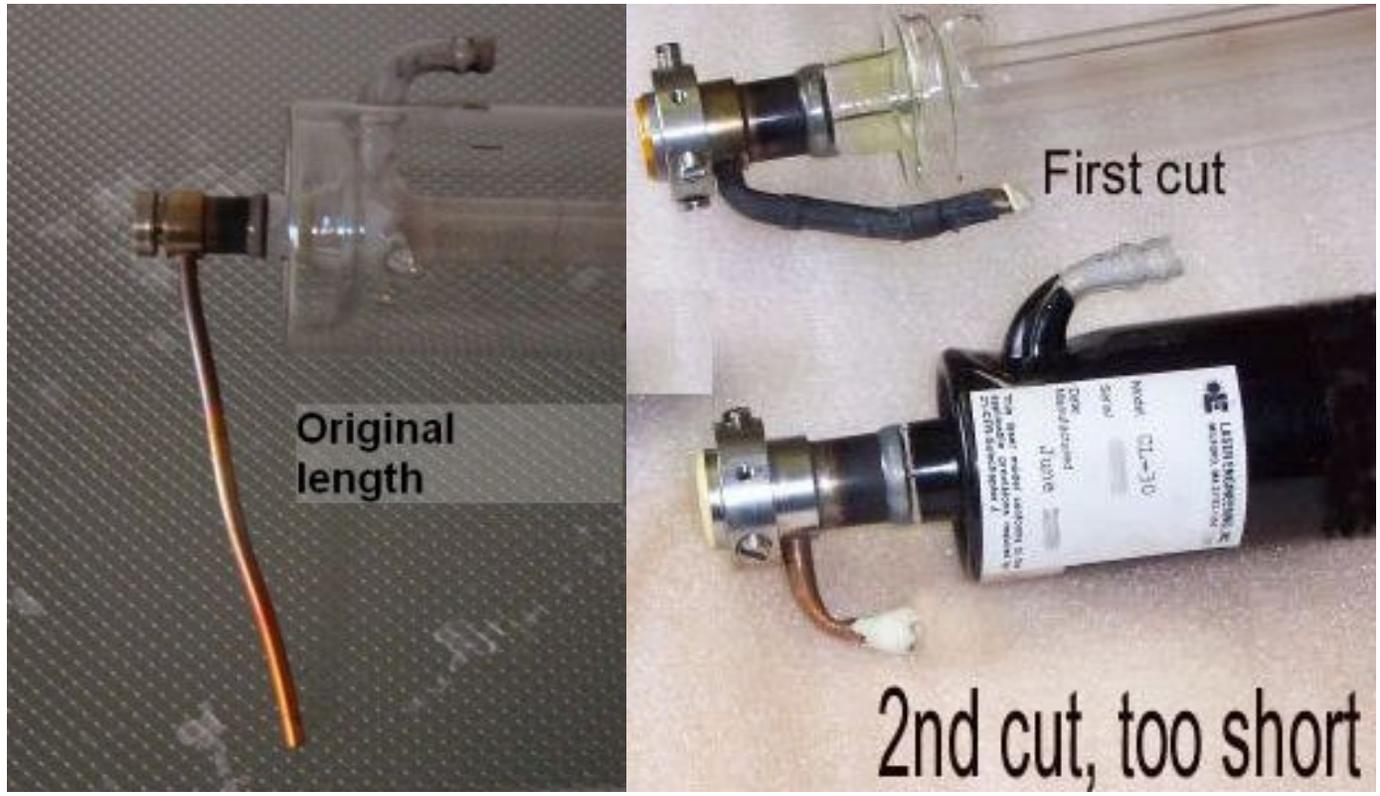
The Copper fill tube on SSI / LEI CO2 tubes becomes too short after 2 refills. This Cu tube is brazed onto the mirror mount so to do a 3rd refill the entire mirror mount assembly must be replaced.
